PREVENTION OF FAILURE TO GIVE A GUARANTEE CONSTRUCTION OF BORED PILES FOUNDATION AT LEMAH IRENG BRIDGE, SEMARANG – SOLO TOLL ROAD, INDONESIA

EDY PURWANTO

Department of Civil Engineering , Faculty of Civil Engineering and Planning, Islamic University of Indonesia,
Yogyakarta, Indonesia

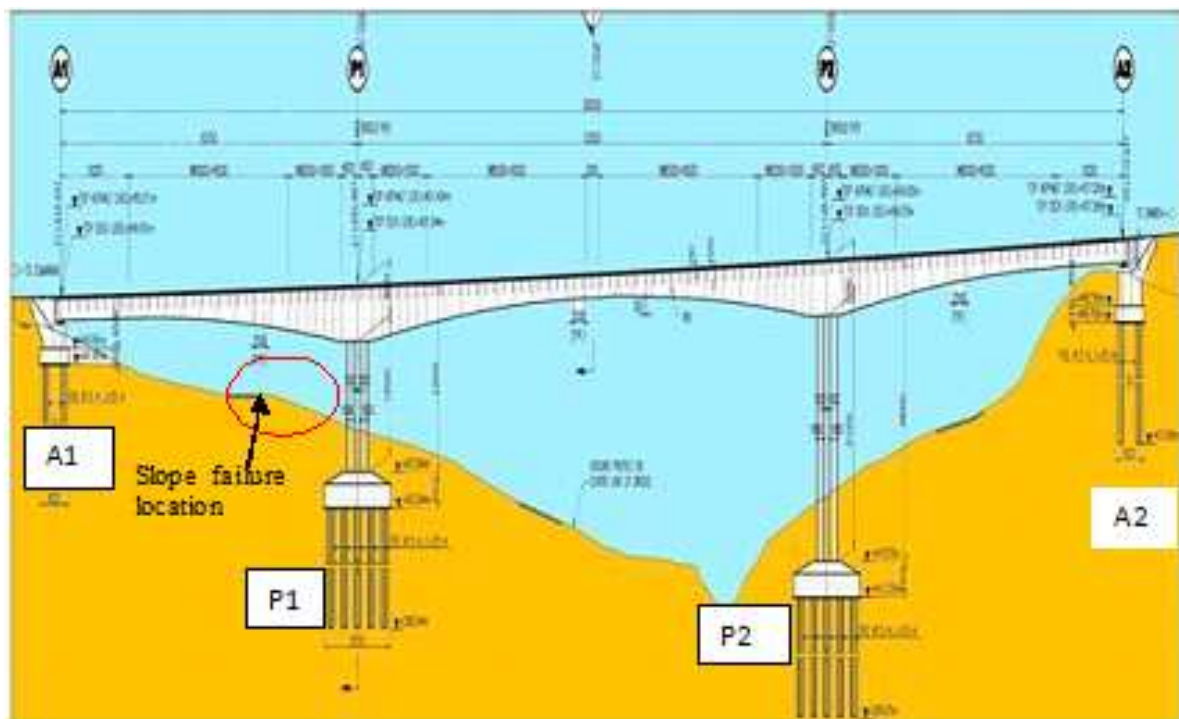
Figure 1: Structure of Lemah Ireng Bridge Sta. 22+625

The main road alinnement passes at the villages, hilley, forresters and agricultures areas. Based on the topography, the bridge should be bulit along from station 22+125 to station 22+840, that is Lemah Ireng bridge. The structure of the bridge consists of two piers (Piers P1 and P2) and two abutments (Abutment A1 and A2). The Lemah Ireng Bridge has tree spans of 85 m – 130 m – 85 m and 25 m width. The upper structure of the bridge is box girder and the sub structure is bored piles foundation. The Construction staging of Lemah Ireng bridge is a balanced cantilever method. (see Figure 1)
